Paul Cornell and Associates

**Inspection Report
prepared for:**

**Property Address:
384 - 386 High Street
Clinton, MA**

Date of Inspection : 6/4/2008	Time Started : 01:00 PM	Time Completed : 05:23 PM
Property Address : 384 - 386 High Street Clinton, MA	Report Prepared For : Kenneth Schalk	Report ID : Clinton_384 - 386 High Street_JUN08

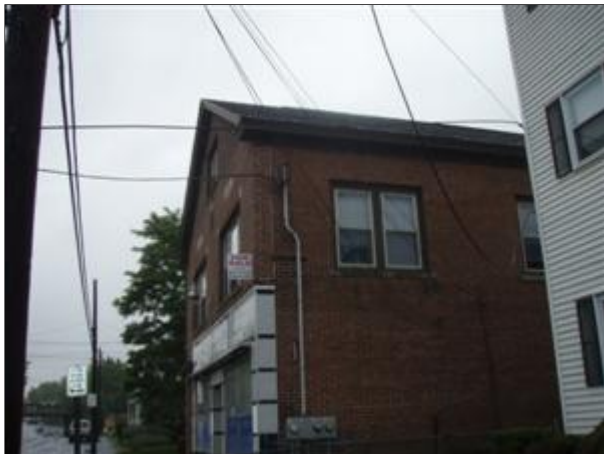
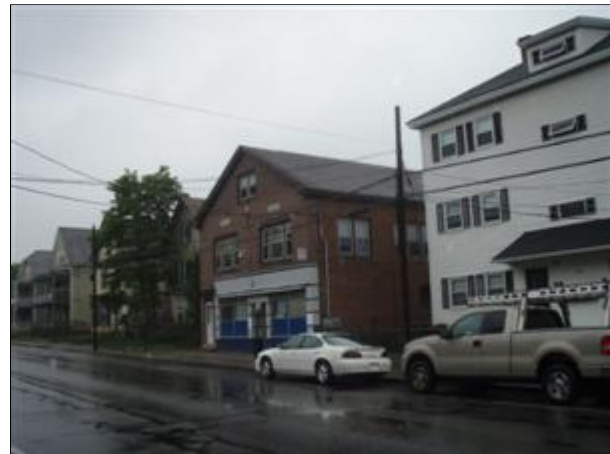
1.0 ACCESS : Evaluation of the roof cover and related flashings was greatly limited due to the height of the house, limited visual access and unsafe ladder access.

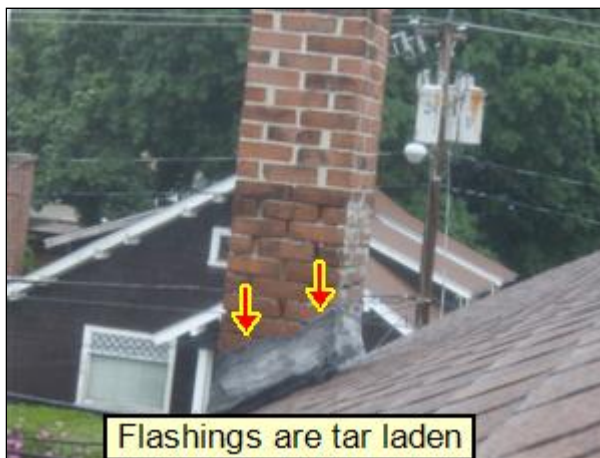
1.2 Picture 1

1.2 FLASHINGS : Lead chimney flashings have been coated with roof cement/tar. This typically indicates that the flashing was damaged, worn and is no longer water tight. This type of application is a temporary repair, at best, and must be periodically repeated to prevent water intrusion. Framing in the attic showed signs of recent water penetration. New flashing should be installed.

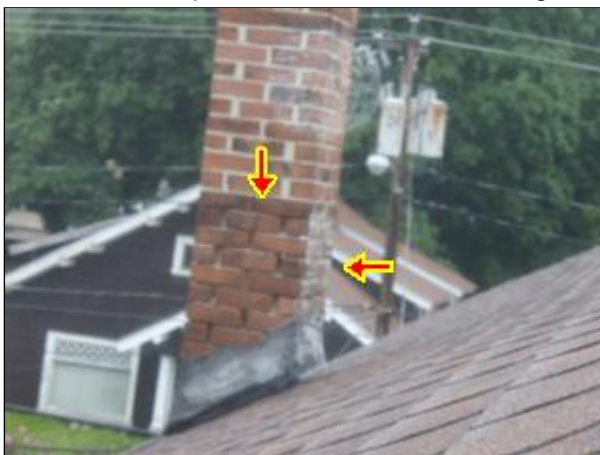
2.0.A Picture 1

2.0.A EXTERIOR SIDEWALLS : Masonry sidewalls of the chimney have deteriorated mortar joints. Proper cleaning and re-pointing is needed. A qualified masonry contractor should be consulted for needed repairs. Once needed repairs are completed sidewalls should be coated with water repellent to resist related damages.

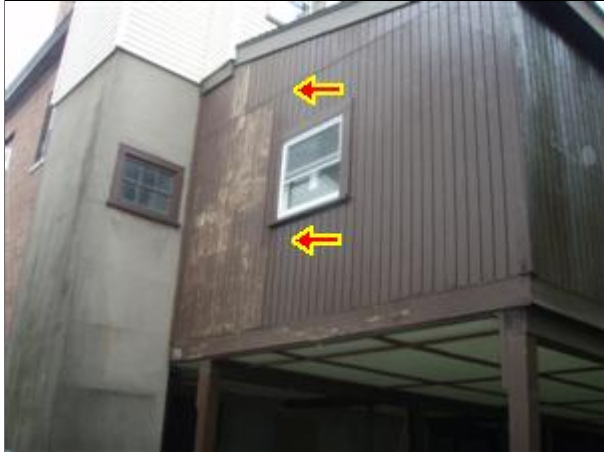
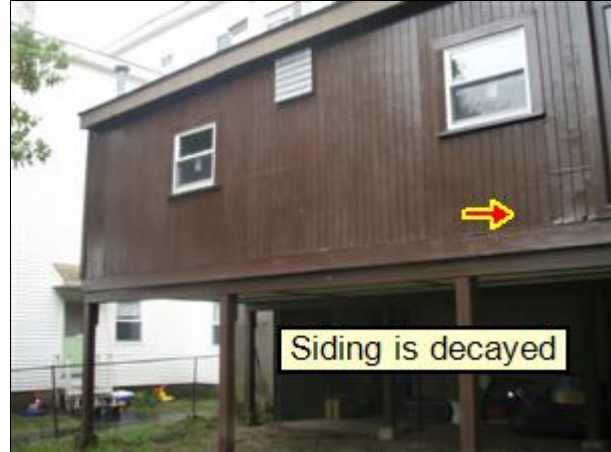
3.0 SIDING : T 111 siding on the right side of the rear addition is not fully painted. Some of this siding is starting to decay and needs to be replaced.

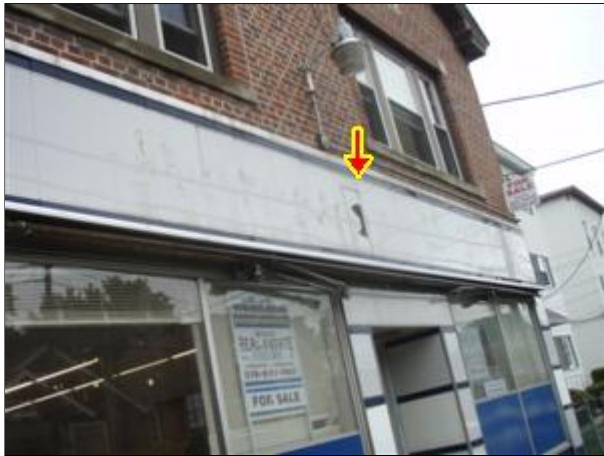
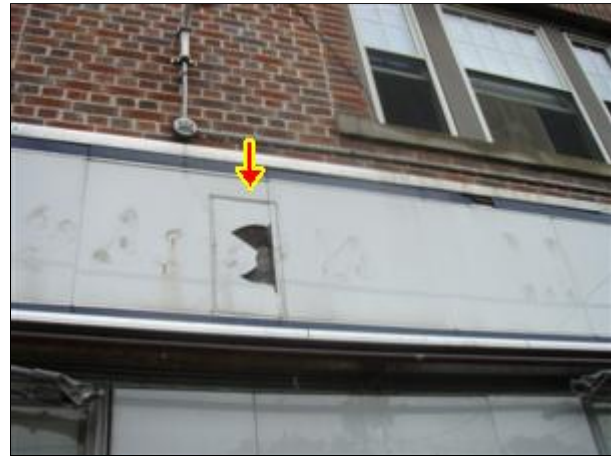
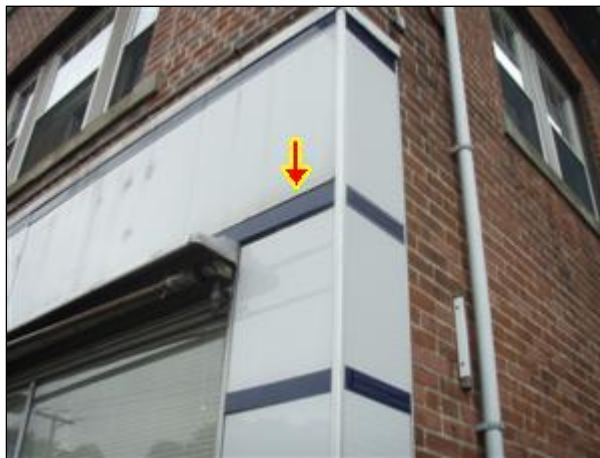
3.2 (1) TRIM : Several pieces of the plastic trim around the store front are damaged and need to be replaced. A few pieces are loose and need to be secured. Some are missing and need to be replaced.

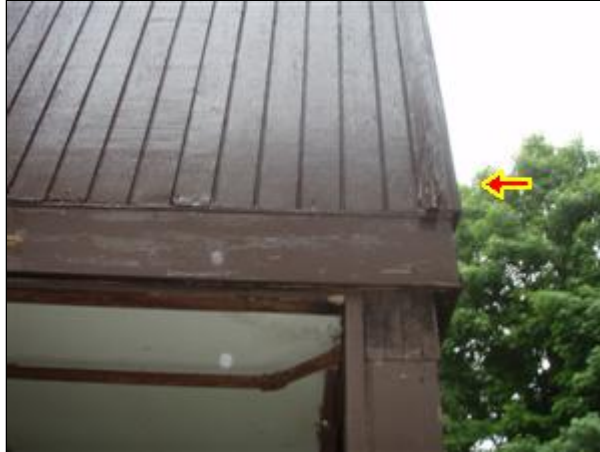
3.2 Picture 4

(2) Wooden trim on the right rear corner of the rear addition is decayed. Replacement is needed.

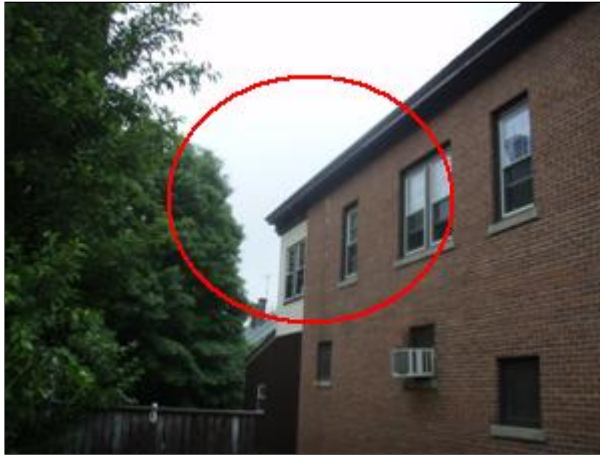
3.3 Picture 1

3.3 FASCIAS AND SOFFITS : Metal coverage on the left rear soffit is loose and falling off. Repairs are needed.

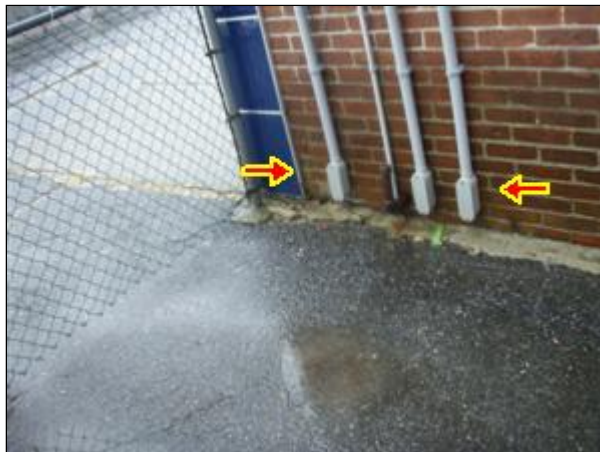
3.4 Picture 1

(2) Conduits through the brick veneer needs to be sealed with caulking.

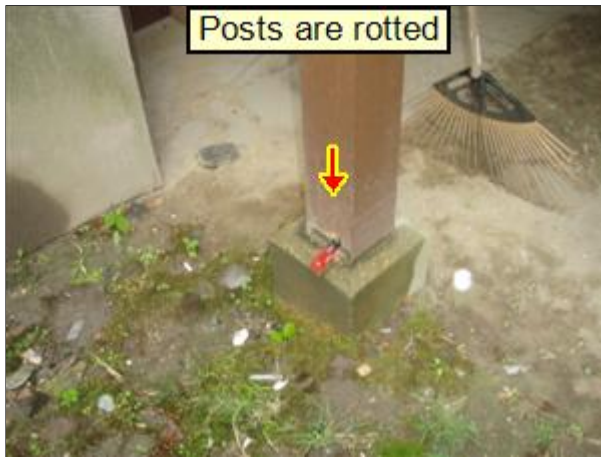
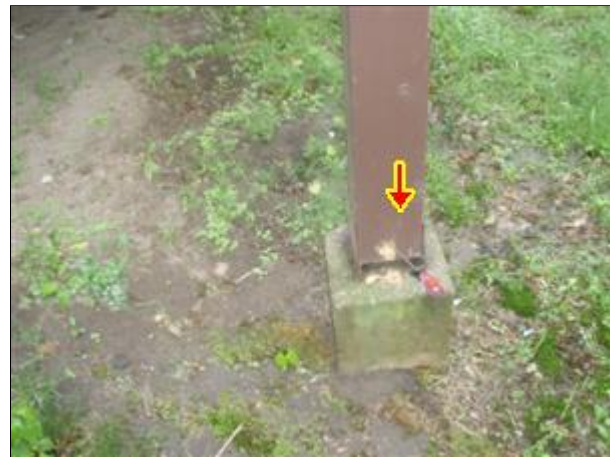
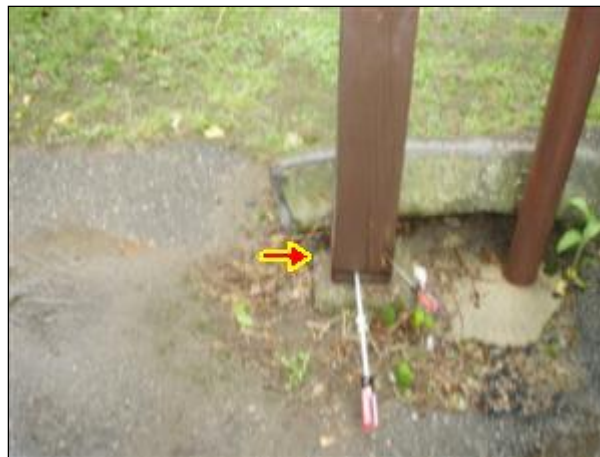
3.12 OTHER OBSERVATIONS : The left rear, right rear and right forward posts supporting the rear addition are water damaged and decayed. Replacement is needed. A qualified & licensed contractor should be consulted for needed repairs.

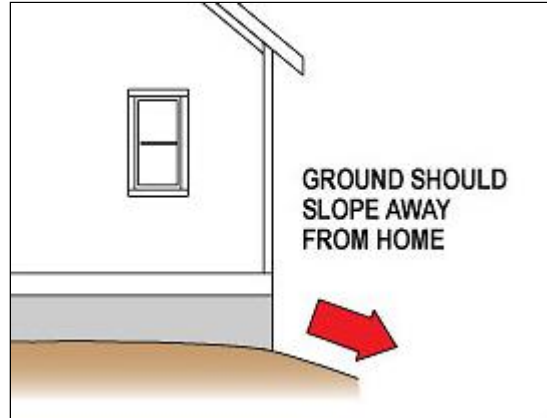
4.3 Picture 1

4.3 FOUNDATION GRADING : For proper drainage foundation grading needs to be built up and maintained to slope away from the house for a minimum of 1" per foot for 5 feet, wherever possible.

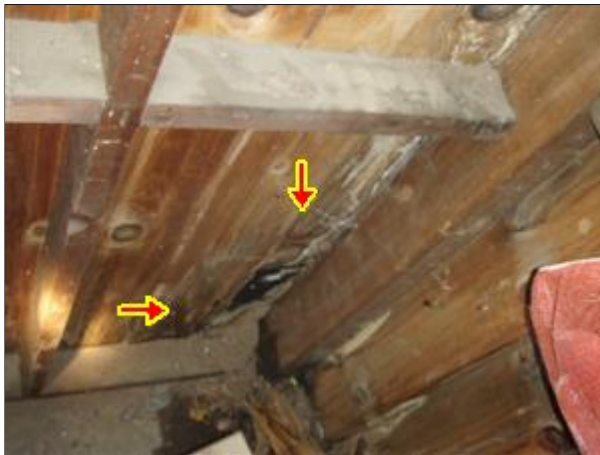
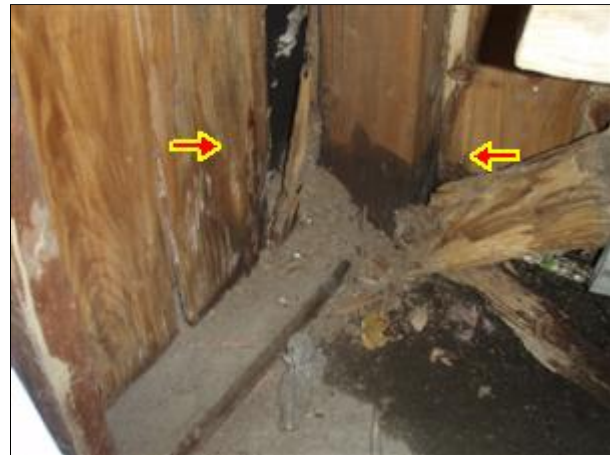
4.8 PORCHES : The wooden post and skirt walls supporting the rear porch are rotted, carpenter ant damaged and termite damaged. Repairs are needed. The post needs to be replaced. Active carpenter ants were observed. Treatment is needed.

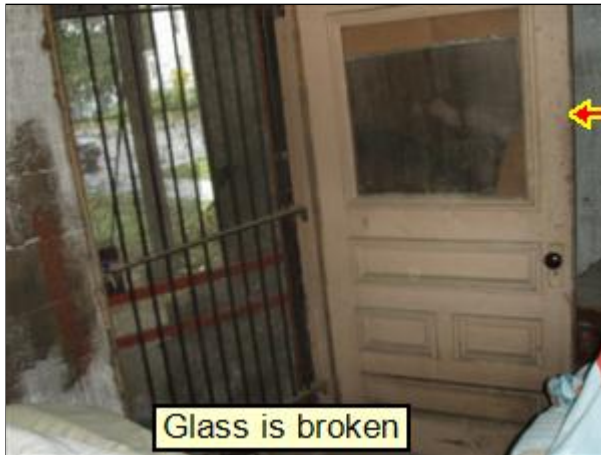
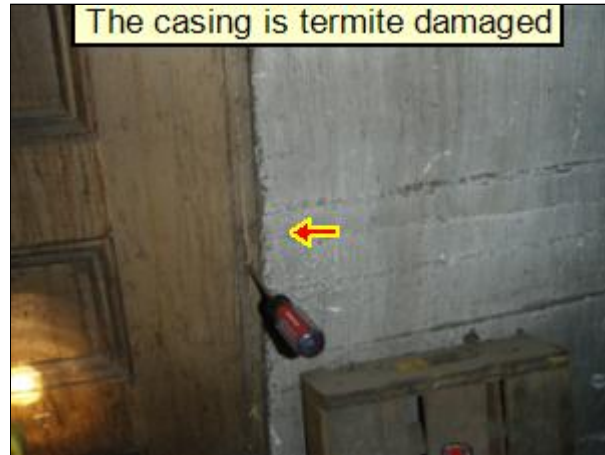
5.0 (1) EXTERIOR DOORS : The cellar entry door has a broken piece of glass. The frame of this door is termite damaged. Complete replacement of the door is needed.

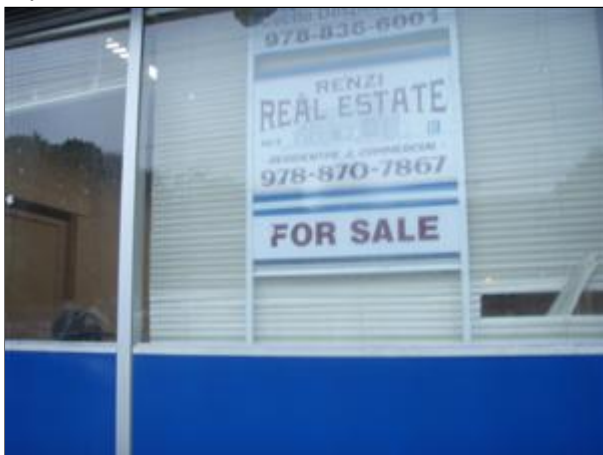
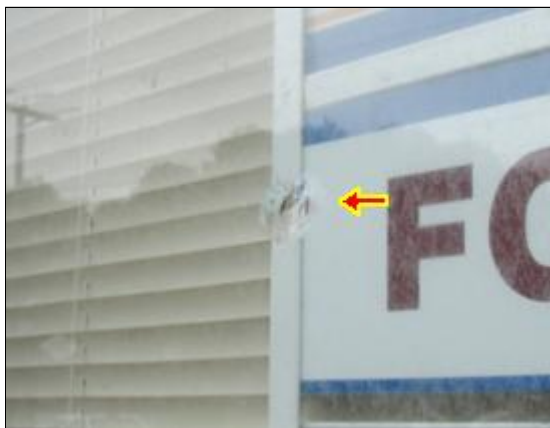
5.1 (1) **PRIMARY WINDOWS, EXTERIOR** : One of the store front windows is damaged, has a hole and needs to be repaired or replaced.

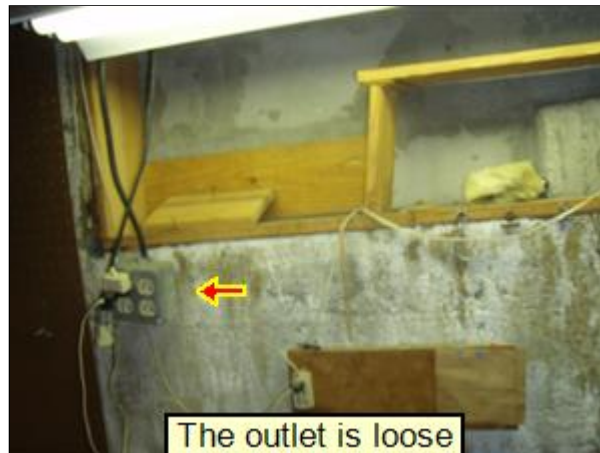
6.5 Picture 1

6.5 OUTLETS, GFCI : The outlet is loose and needs to be secured. The outlet is not GFCI protected as is current standard. Updating is recommended as GFCI protection can prevent shock or electrocution. A licensed electrician should be consulted.

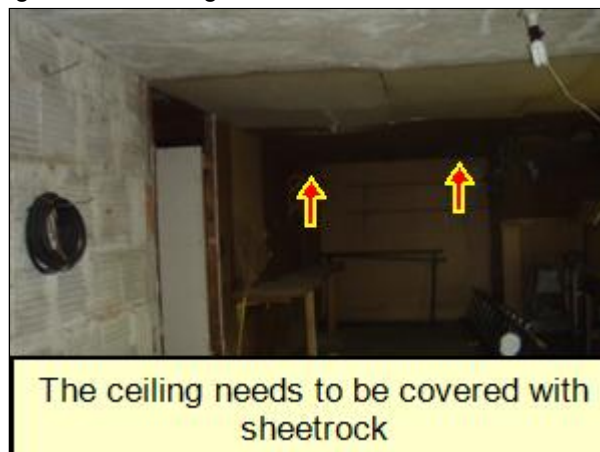
6.8 Picture 1

6.8 FIRE SEPARATION : The ceiling needs covering with fire rated sheetrock.

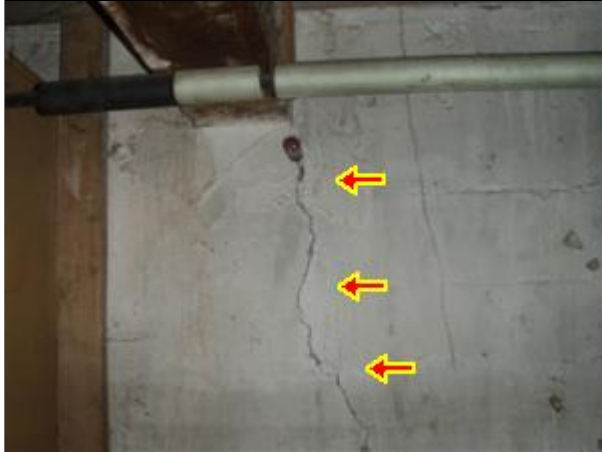
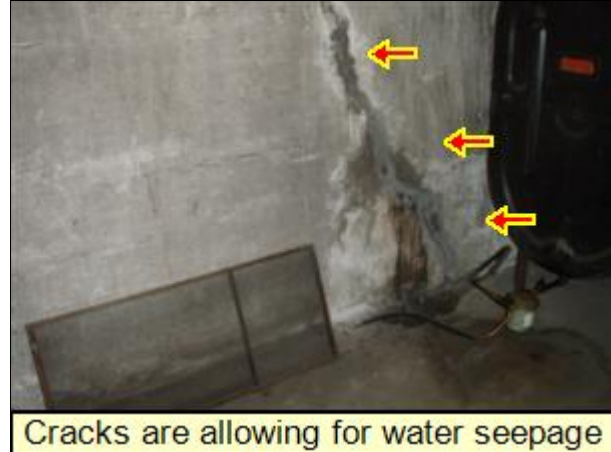
7.2 FOUNDATION WALLS : Foundation walls show typical and expected settlement cracking. Cracks of this nature can allow for water seepage and cold air infiltration. Repair with epoxy injection is recommended.

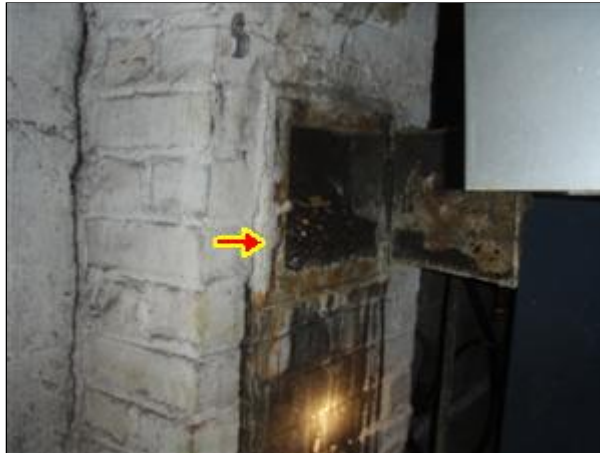
7.4 Picture 1

7.4 CHIMNEY BASE : The chimney base is full of debris and needs to be cleaned. Immediate attention is needed as debris within can obstruct the flue passage at the flue pipe connection from the heating system and allow for flue gas spillage into the house. A certified chimney sweep should be consulted at once.

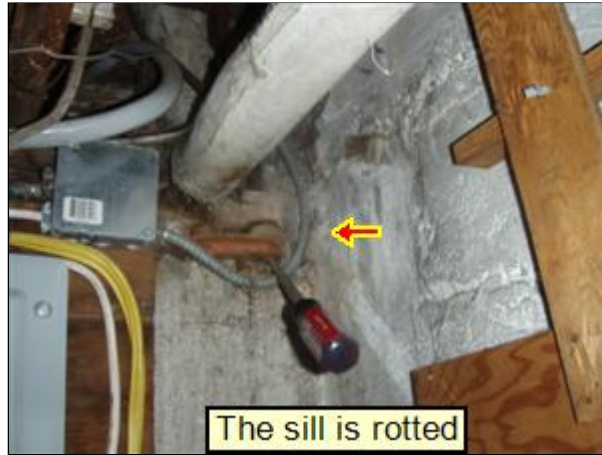
7.5 Picture 1

7.5 (1) **JOISTS / SILLS** : The sill at the right front of the basement is water damaged and needs to be replaced.

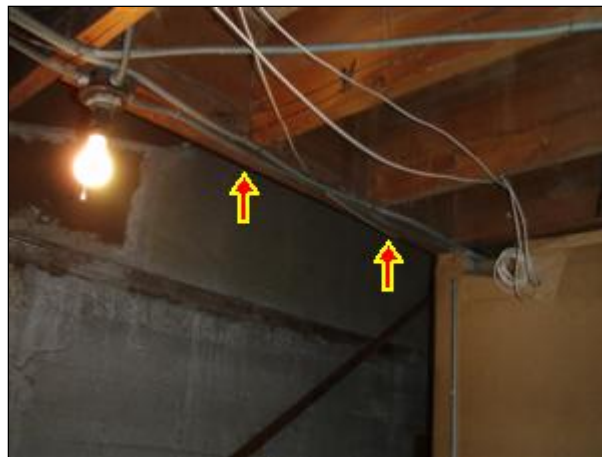
7.5 Picture 2

(2) Joist ends at the stairway framing header should be carried by hangers to resist nail bend or separation.

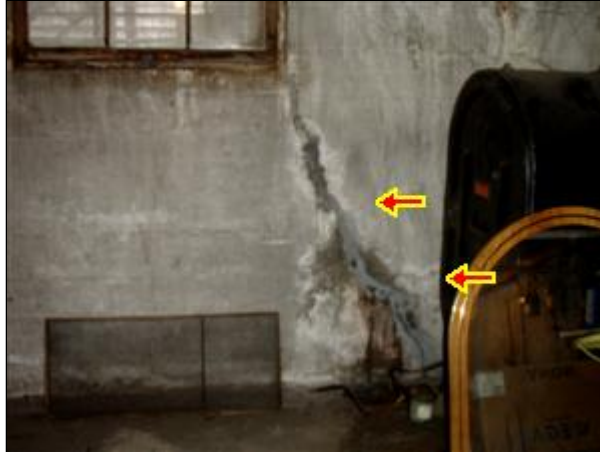
7.9 Picture 1

(2) The basement shows signs of recent water seepage through the foundation. Cracks in the foundation need to be repaired. Epoxy injection is recommended. Exterior conditions as noted on the drainage section of the report appear to be a contributing factor to water issues and should be addressed.

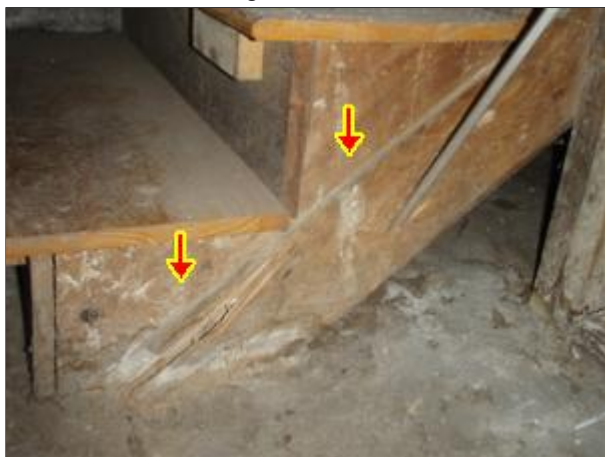
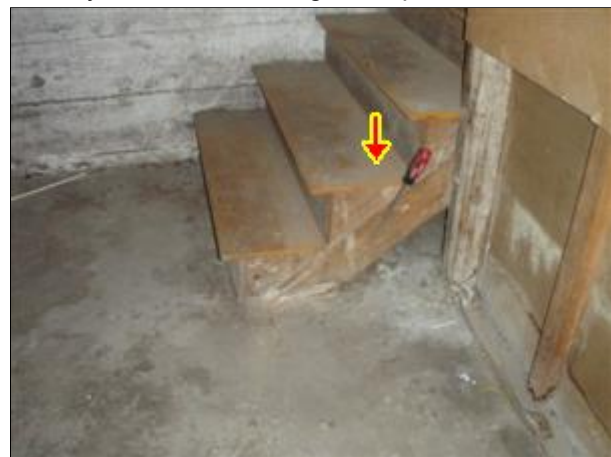
7.12 CELLAR STAIRS : Stringers at the bottom of the cellar stairway are termite damaged. Repair is needed.

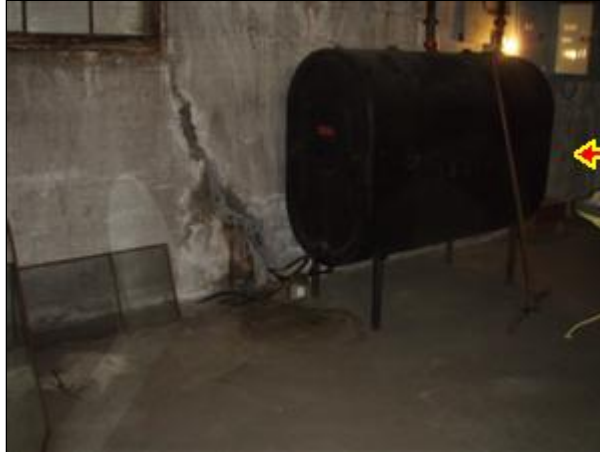
7.13 Picture 1

7.13 (1) OTHER OBSERVATIONS : The abandon oil tank at the right front corner of the cellar should be removed as it can no longer be used. The local fire marshall should be consulted on regulations for abandon tanks.

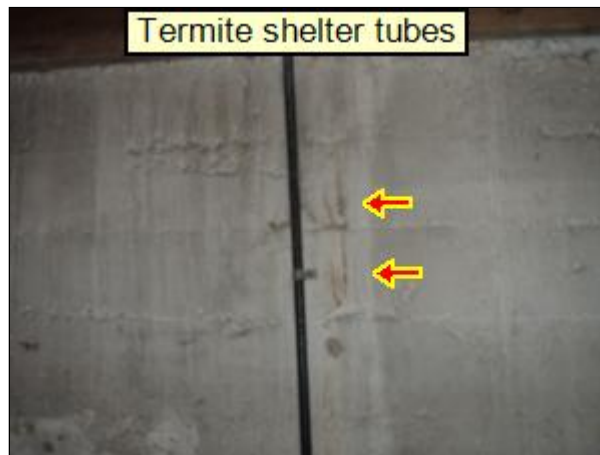
7.13 Picture 2

(2) Termite shelter tubes were noted on the front foundation wall. Termite damage was noted to the bottom of the cellar stair stringers and the frame of the basement door. treatment for termites is recommended. A licensed pest control specialist should be consulted.

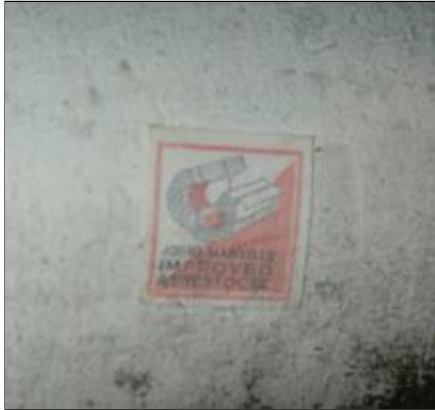
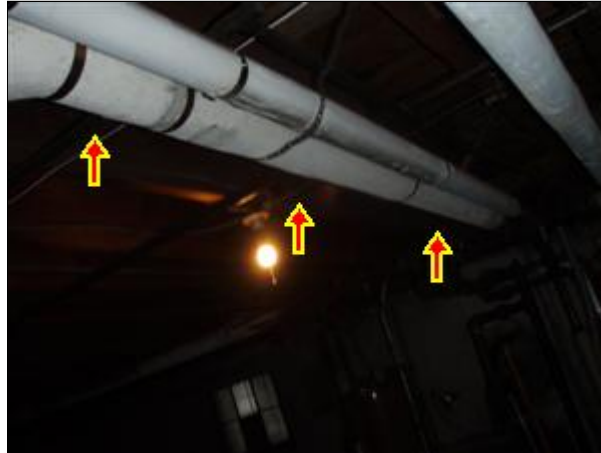
9.4.B EXPOSED PIPES / VALVES AND FITTINGS : Insulation on heat pipes appears to contain asbestos. Much of this insulation throughout the cellar area is damaged, loose and can pose an environmental hazard and health risk. Removal is recommended. A licensed abatement contractor should be consulted for further evaluation and cost estimates, **prior to commitment**.

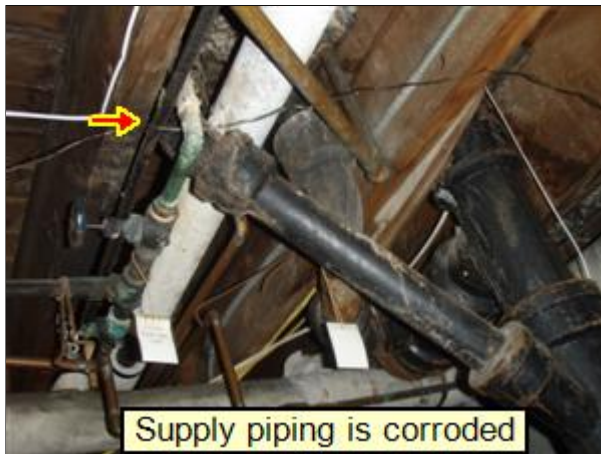
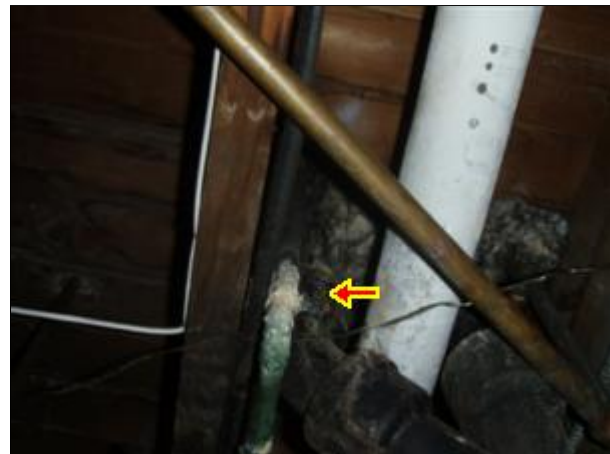
10.0 (1) VISIBLE SUPPLY PIPES : There is a fair amount of original supply plumbing is still in service. Visible pipes and fittings show evidence of serious corrosion at threaded joints and are leaking. Replacement is needed.

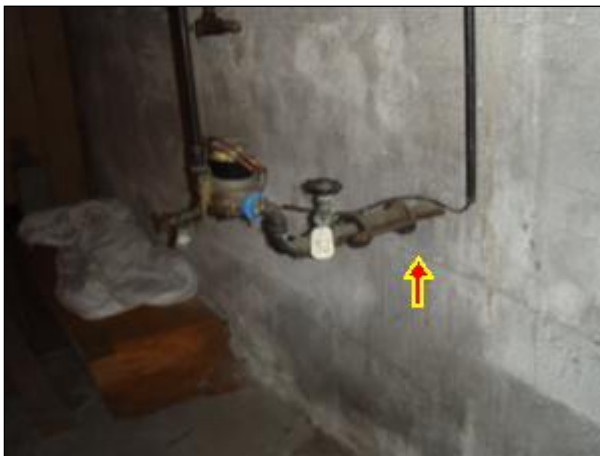
10.0 Picture 3

(2) The main water line in from the street is steel. This type of piping tends to rust internally as it ages and can restrict water volume and pressure. Replacement is typically the responsibility of the home owner. The local water department should be consulted.

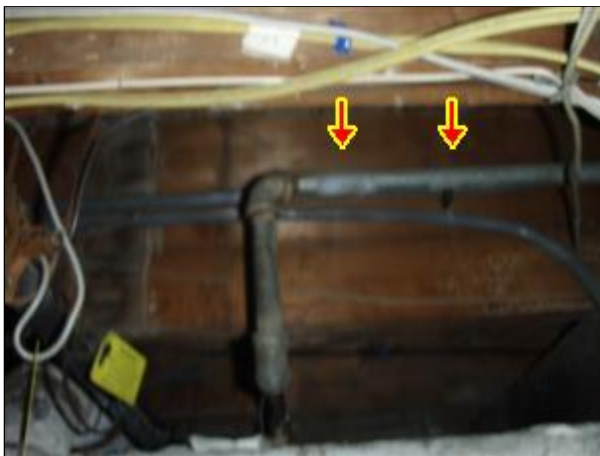
10.0 Picture 4

(4) Galvanized supply pipes for the exterior faucets should be replaced as needed.

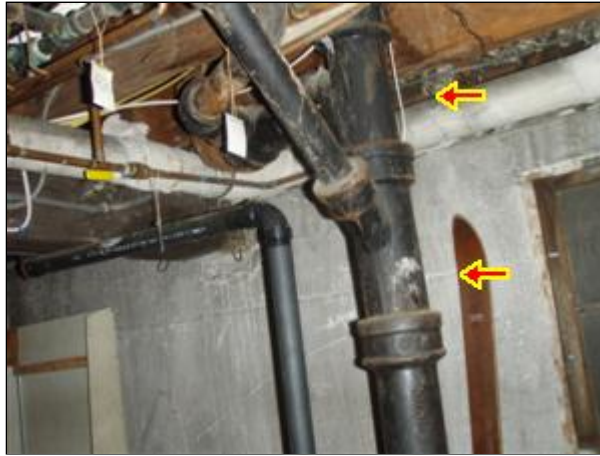
10.1 Picture 1

10.1 (1) VISIBLE WASTE AND VENT PIPES : There is a fair amount of older waste plumbing still in use. Waste plumbing from the tub in the 2nd floor is leaking and needs immediate repair. Waste plumbing for the 2nd floor kitchen sink and washer drain is not properly configured and will be problematic with clogging and siphoning issues. Correction is needed. A licensed plumber should be consulted for further evaluation , prior to commitment.

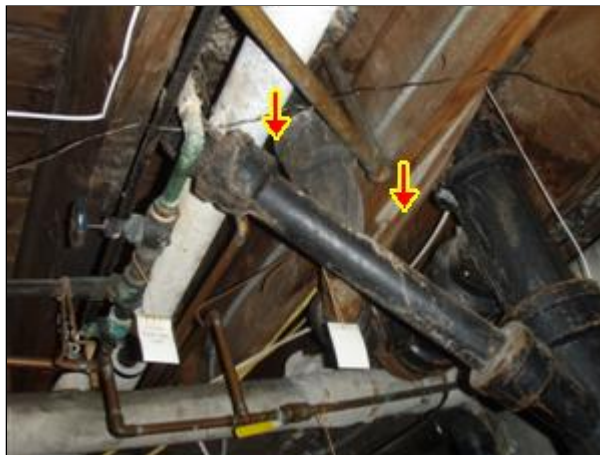
10.1 Picture 2

(2) Some of the waste pipes are older cast iron. Cast iron pipes corroded and rust internally and will eventually fail. Rust stains, cracks and stallagites are usually an indication the pipe is about to fail.

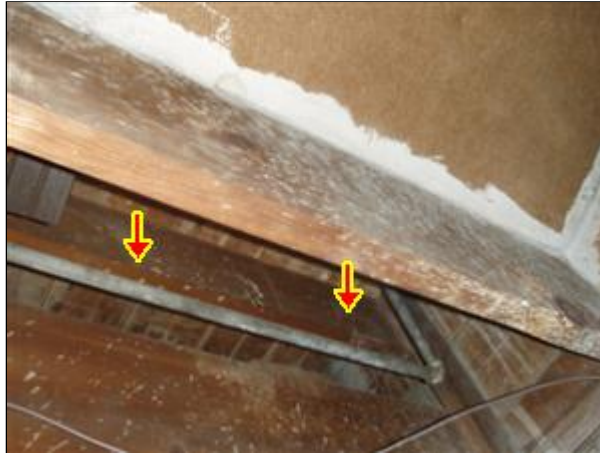
10.4 Picture 1

10.4 OTHER OBSERVATIONS : Galvanized steel pipes were used for gas supply. Galvanized steel is not allowed for gas supply. Replacement with an approved material is needed. A licensed plumber should be consulted for further evaluation and needed repairs.

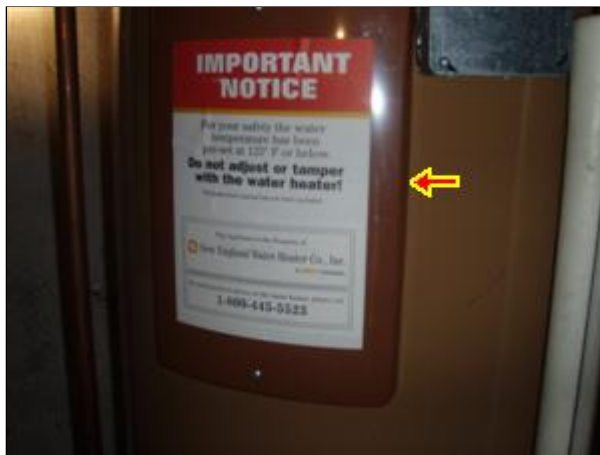
11.6 Picture 1

11.6 OTHER OBSERVATIONS : The water heater has a tag indicating it is rented. The owner should be consulted.

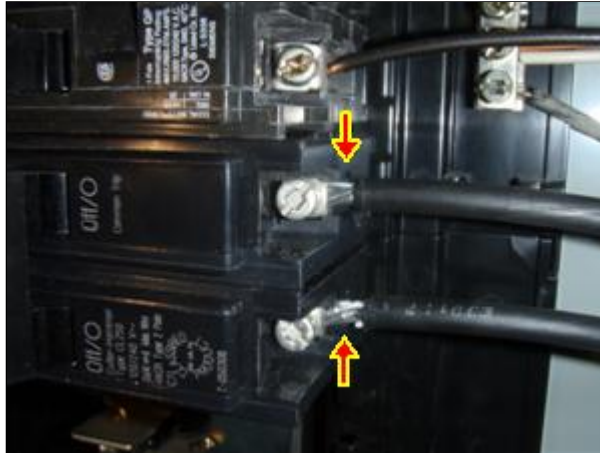
12.3.A Picture 1

12.3.A CIRCUIT BREAKERS : The panel is rated for 20 breakers, it has 13. All circuits appear to be properly protected at this time. Aluminum service cables connected to terminals of the 40 amp 220 volt circuit breaker need to be coated with an anti-oxidant compound to prevent corrosion, resistance and to ensure a good bond.

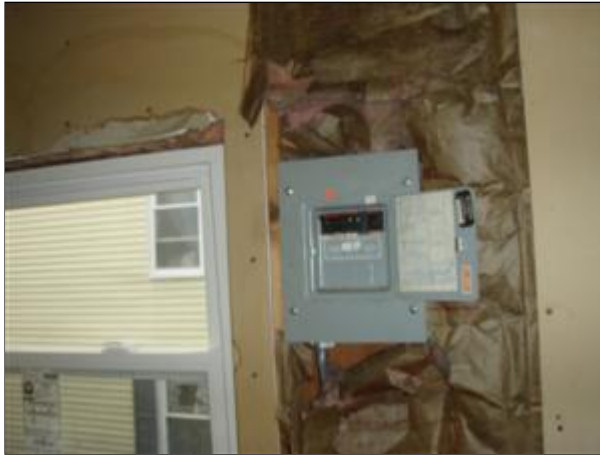
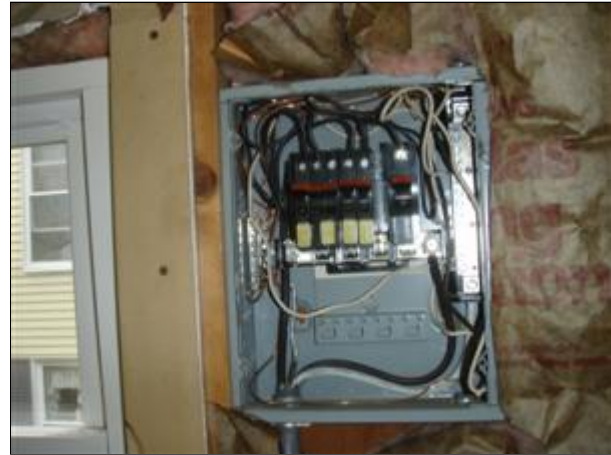
12.4.A (1) SUB PANEL : The panel is manufactured by Federal Pacific. Federal Pacific breakers have known latent defects and may not disconnect power in the case of an overload. This could pose a fire hazard. Breakers can also arc where they attach to the buss. Replacement of the panel is recommended. A licensed electrician should be consulted for further evaluation, **prior to commitment**. See the attached link for additional information: <http://www.inspect-ny.com/fpe/fpepanel.htm>

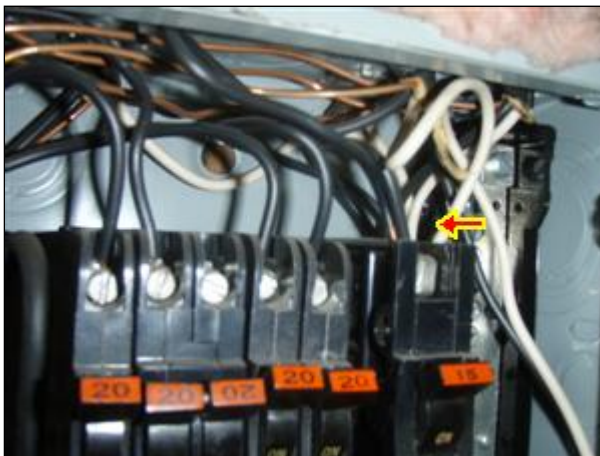
12.4.A Picture 3

(2) One circuit breaker in the panel is double tapped. This is typically not permitted as terminals on breakers are designed to secure only one wire. Loose wires could result in overheating. This could also result in nuisance tripping of the breakers if both circuits are being used simultaneously. These wires should be broken up to individual breakers.

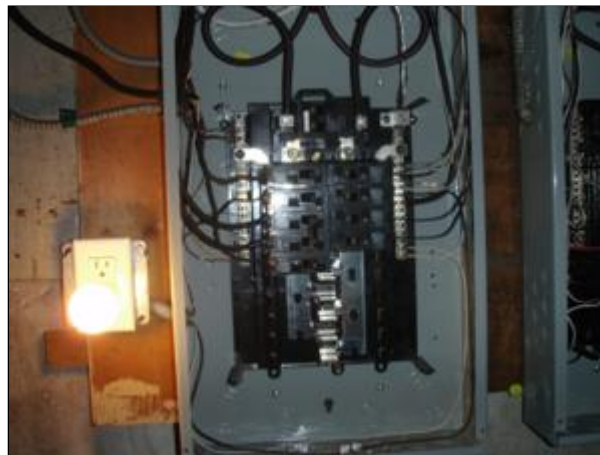
12.3.C Picture 1

12.3.C CIRCUIT BREAKERS : The panel is rated for 20 breakers, it has 9. All circuits appear to be properly protected at this time.

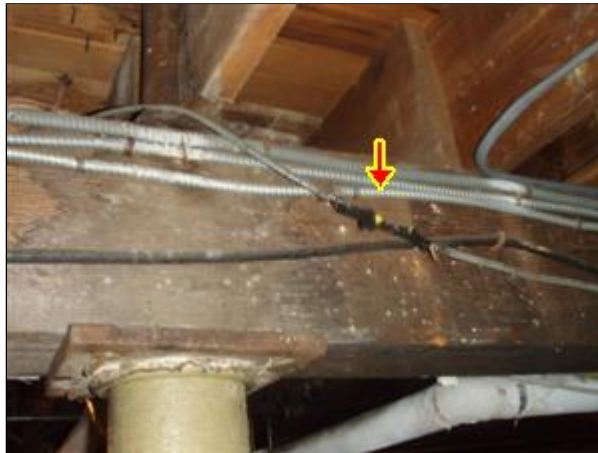
12.5.C Picture 1

12.5.C OTHER VISIBLE WIRING : Loose wiring throughout the basement needs to be properly secured. Secondary wiring throughout the basement is sloppy and appears non professional. Wire splices need to be made in secure junction boxes. A licensed electrician should be consulted for further evaluation and needed repairs.

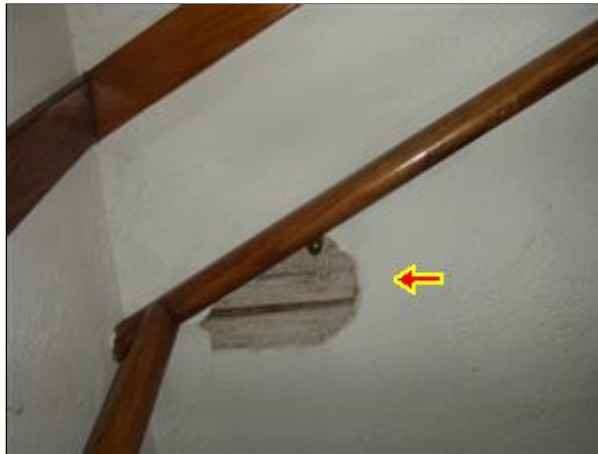
14.0 Picture 1

14.0 (1) WALLS AND CEILINGS : Walls and ceiling show a need for general cosmetic care and touch up. Some of the plaster in the 2nd floor hallway is damaged, loose and needs repair.

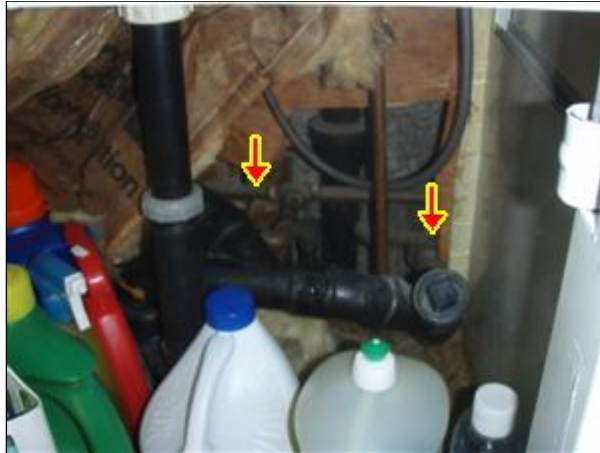
15.12 Picture 1

15.12 EXPOSED WASTE PIPING : Waste plumbing is not properly configured, will be prone to clogging and leaking problems. Correction is needed. The drain is an S trap which are no longer permitted as they are not vented and prone to siphoning. A licensed plumber should be consulted.

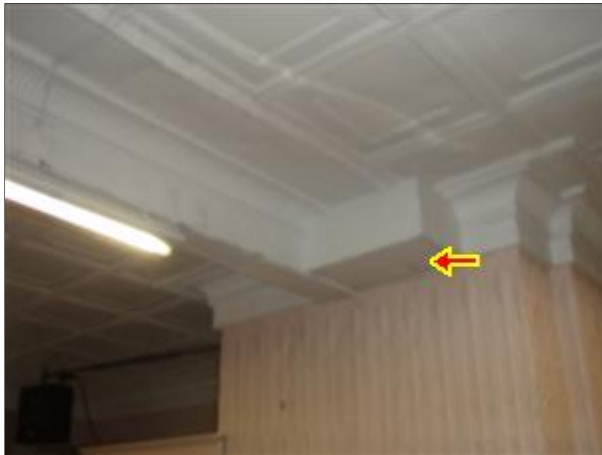
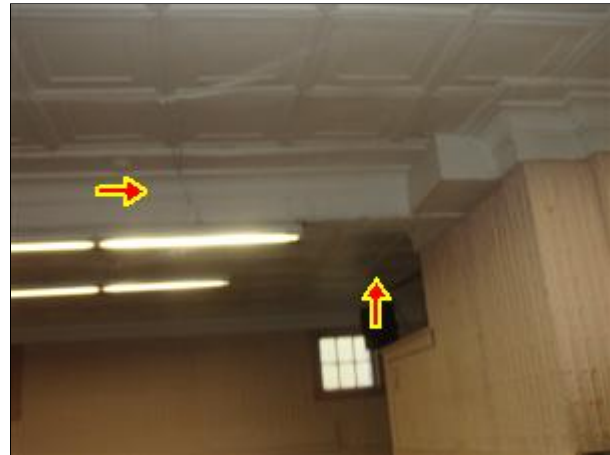
(2) The ceiling below the 2nd floor bathroom is water damaged.

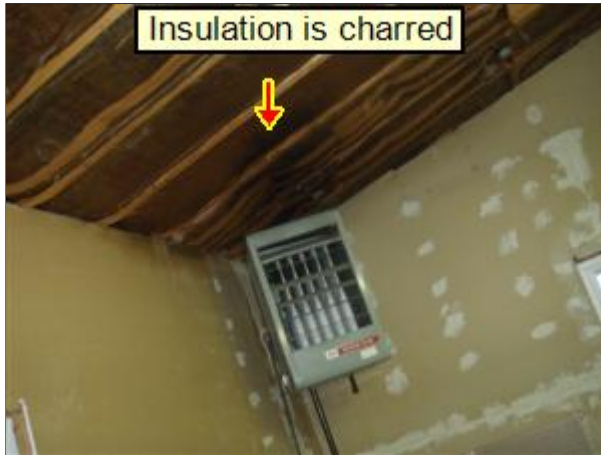
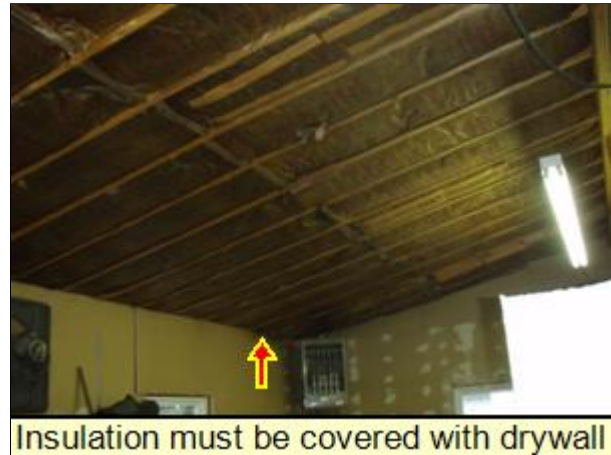
(3) Exposed insulation in the rear store room is flammable and must be covered by sheetrock. Insulation above the furnace is charred and burnt. Immediate correction is needed.

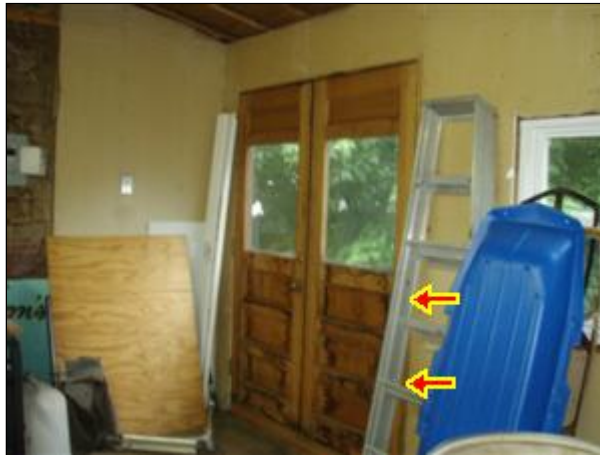
16.4.C Picture 1

16.4.C The rear doors are less than weather tight. Removal or replacement is needed.

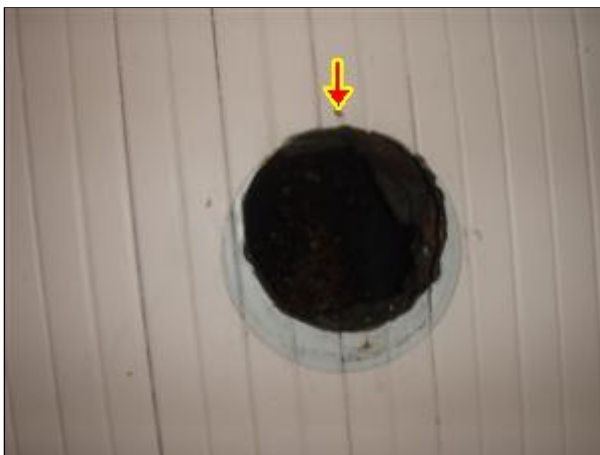
16.9.C Picture 1

16.9.C (1) The hole in the chimney can allow for flue gas spillage and poses a fire hazard. This opening needs to be properly capped and sealed off. Immediate correction is needed as hazards exist A qualified chimney weep should be consulted for correction.

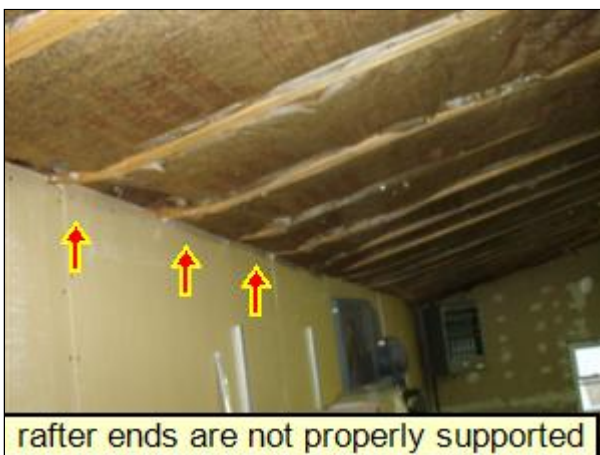
16.9.C Picture 2

(2) Rafters of the rear store room room are not properly supported by the rear wall. Repairs are needed. A qualified contractor should be consulted.

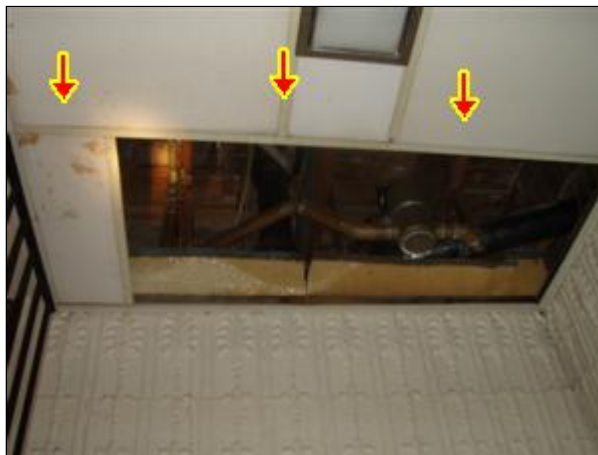
18.0.A Picture 1

18.0.A The ceiling is water damaged due to the leaking bathroom above.

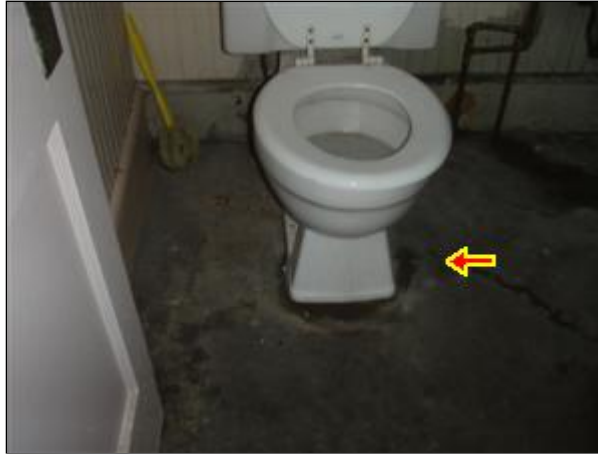
18.11.A Picture 1

18.11.A The toilet is leaking at the floor. Immediate repair is needed.

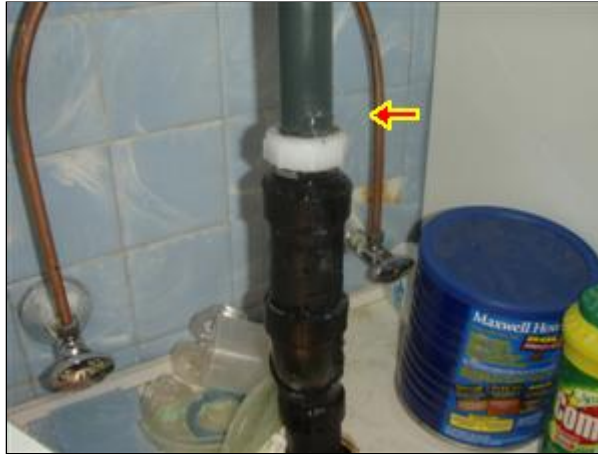
18.11.B Picture 1

18.11.B The tailpiece is leaking and needs to be repaired.

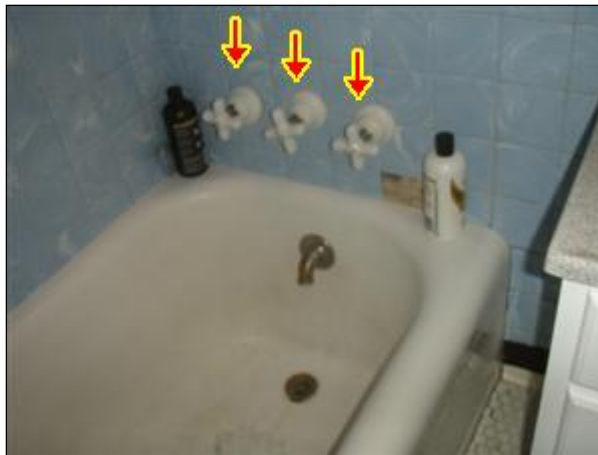
18.18.B Picture 1

18.18.B Tub faucets are leaking and need to be rebuilt. Tub faucets should be updated with an anti scald valve. A licensed plumber should be consulted. The tub spout is within the flood level of the tub and poses a cross connection.

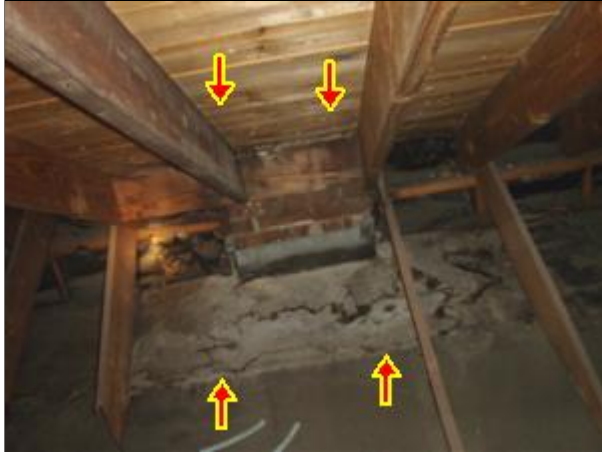
19.3 Picture 1

19.3 Active water penetration was noted around the chimney. This can be attributed to the condition of flashings as noted on the roof section of the report. Immediate attention is needed.

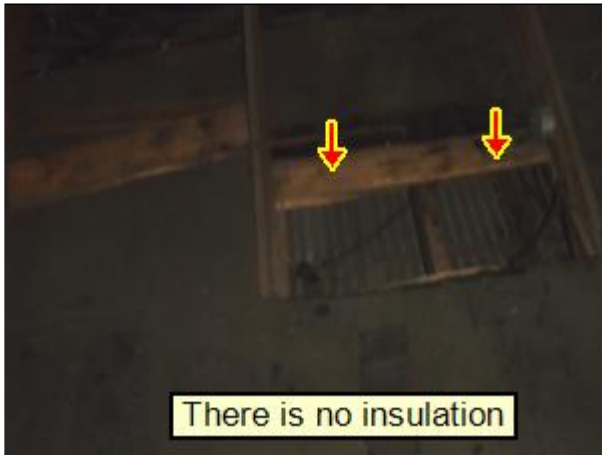
19.5 Picture 1

19.5 The attic is not insulated. The attic floor should be blown full of insulation for energy efficiency. It is recommended that you add additional insulation to bring "R" value to 30 or 40. Penetrations such as plumbing vents, wires and recessed light fixtures are a big source of heat loss and should be sealed with an expanding foam insulation. An insulating contractor or an energy efficiency specialist should be consulted for further evaluation and cost estimates. A well insulated attic can dramatically reduce heating and cooling expenses by nearly 30 %. For more information check the attached link. <http://www.masssave.com/> .
