Paul Cornell and Associates

**Inspection Report
prepared for:**

**Property Address:
384 - 386 High Street
Clinton, MA**

Date of Inspection : 6/4/2008	Time Started : 01:00 PM	Time Completed : 05:23 PM
Property Address : 384 - 386 High Street Clinton, MA	Report Prepared For : Kenneth Schalk	Report ID : Clinton_384 - 386 High Street_JUN08

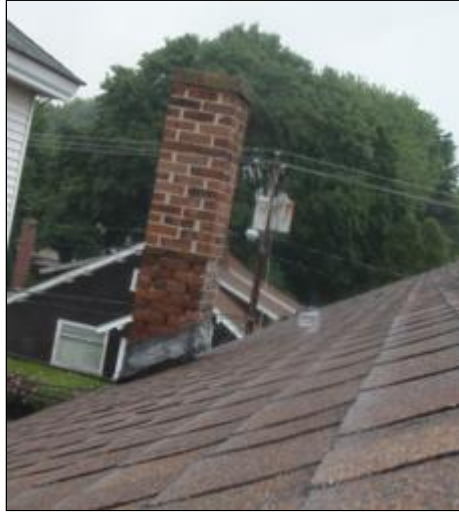
2(A). RIGHT CHIMNEY

2.0.A EXTERIOR SIDEWALLS : Masonry sidewalls of the chimney have deteriorated mortar joints. Proper cleaning and re-pointing is needed. A qualified masonry contractor should be consulted for needed repairs. Once needed repairs are completed sidewalls should be coated with water repellent to resist related damages.

2.1.A FLUE LINING(S) : Flue lining condition could not be evaluated as the chimney top was not safely accessible. A certified chimney sweep should be consulted for further evaluation. A level 2 inspection is recommended.

2.3.A RAIN CAP/ANIMAL SCREEN : The chimney has no rain cap/ animal screen. The lack of a rain cap animal screen can allow for water penetration and wildlife to nest in the flues. The installation of a rain cap/animal screen that encompasses the entire chimney top is recommended.

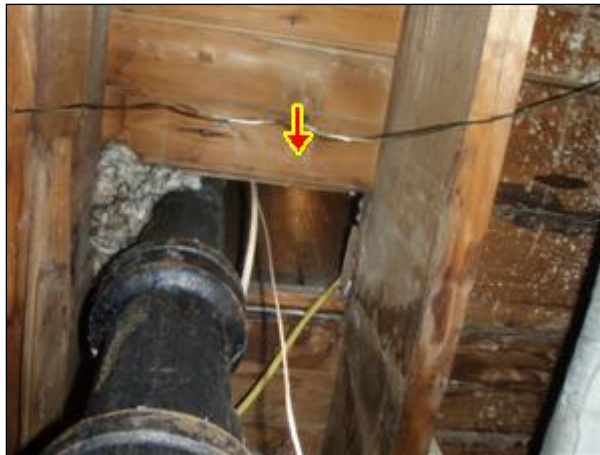
7.11 Picture 1

7.11 (1) INSULATION / FIRE STOPPING : Plumbing chases and framing by the chimney need to be fire stopped.

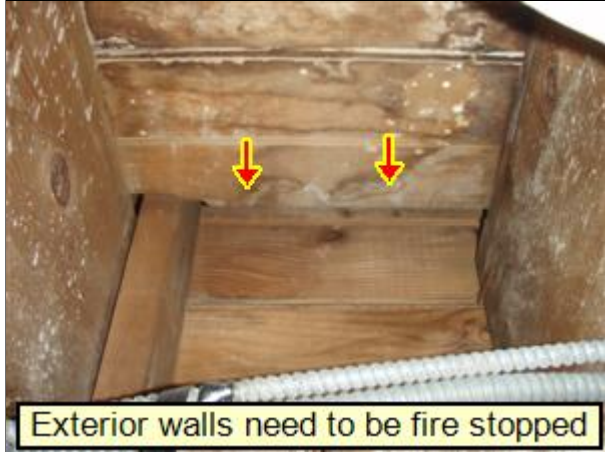
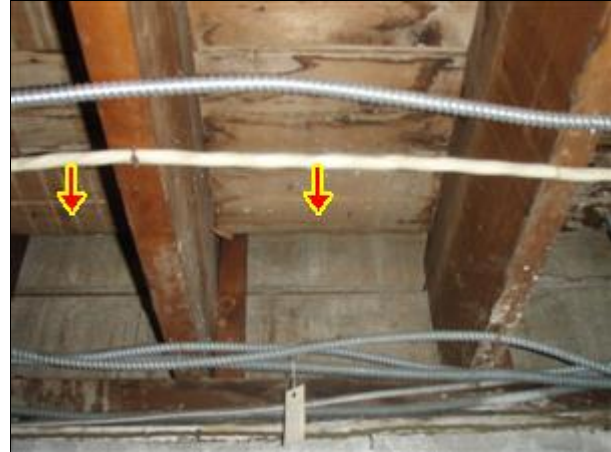
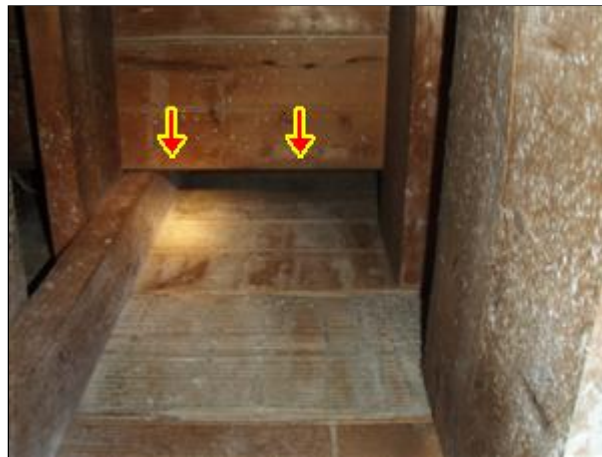
(2) The building is balloon framed. Exterior wall framing above sills needs to be fire stopped.

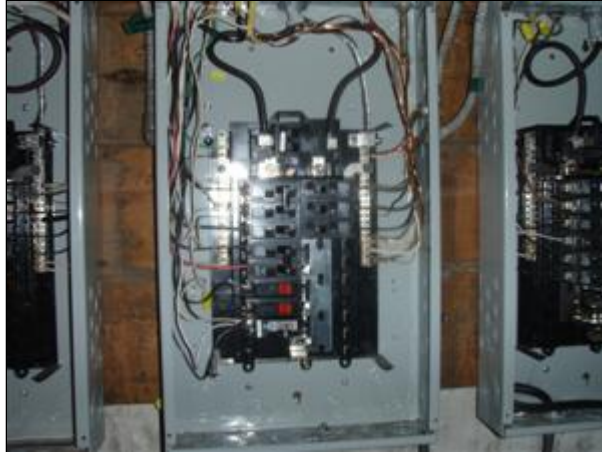
12.3.B Picture 1

12.3.B CIRCUIT BREAKERS : All circuits appear to be properly protected at this time. The panel is rated for 20 breakers, it has 11.
